PHASE I INSPECTION REPORT  
NATIONAL DAM SAFETY PROGRAM

**COTTONWOOD DAM  
WILSALL, MONTANA  
PARK COUNTY  
MT 21**

HKM ASSOCIATES  
BILLINGS, MONTANA

FEBRUARY 1981

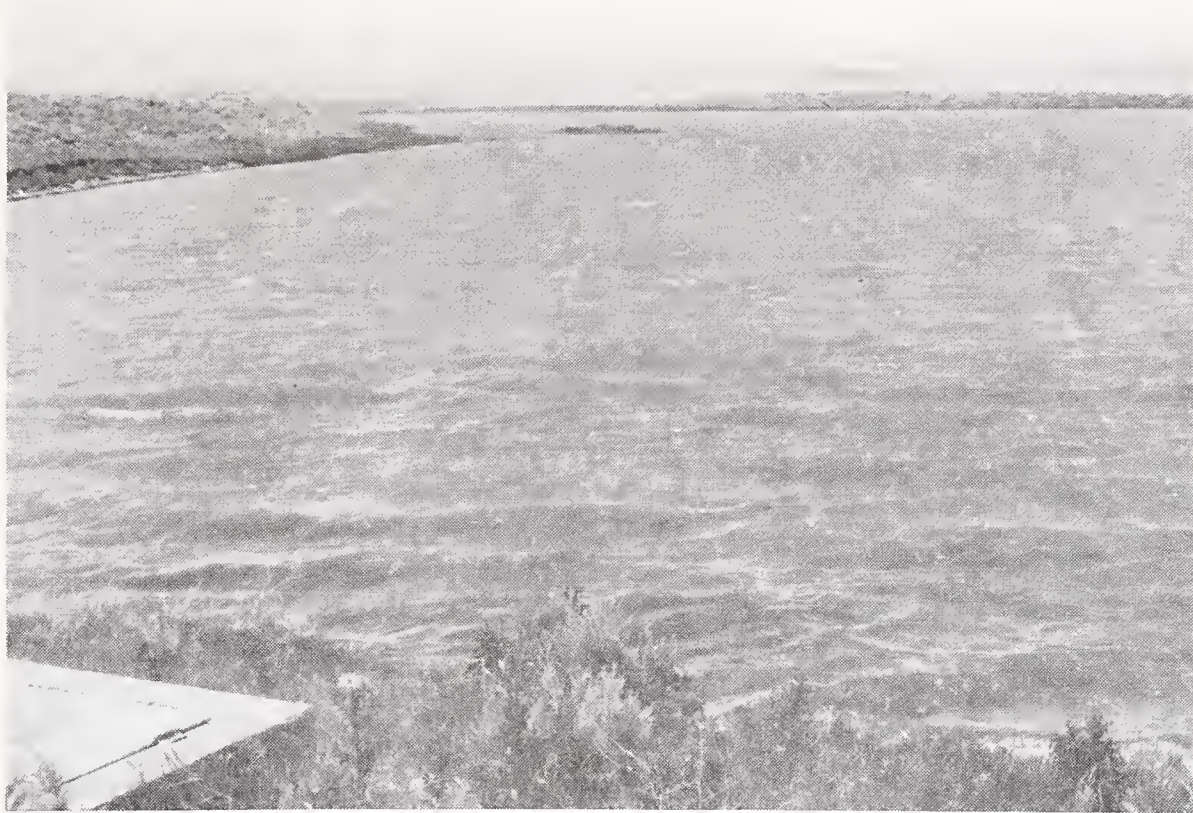
occasionally vertical, or near vertical, to heights of about 2 feet and localized sloughing occurs due to wave action and saturated conditions (Photo 1 of Appendix B).

Photo No. 1 - Upstream Watershed  
The reservoir banks are sloughing at the upper left side of the photo.

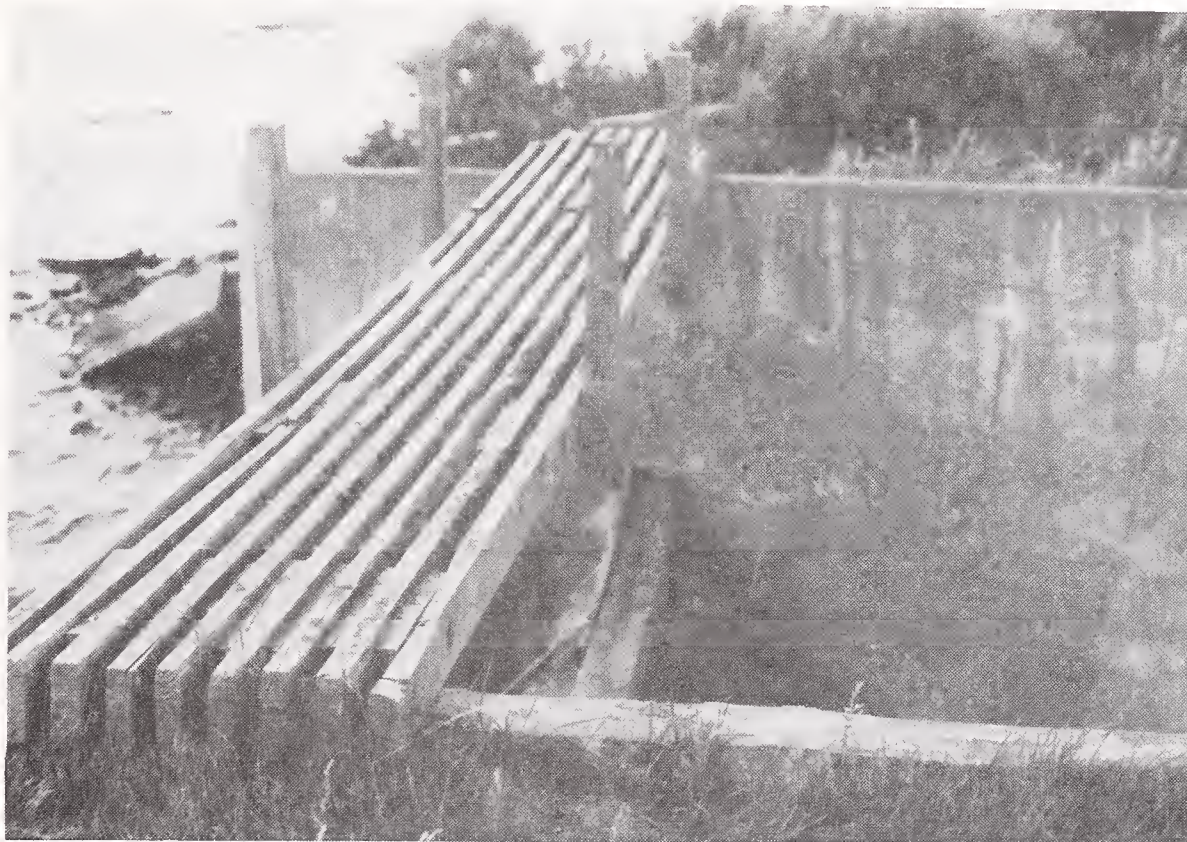
across the spillway crest is in very bad condition with the handrails missing (Photo 2 of Appendix B). The condition of the catwalk has been mentioned in previous inspection reports (Ref. 7).

Photo No. 2 - Catwalk over Spillway  
The catwalk is in poor condition and missing handrails.

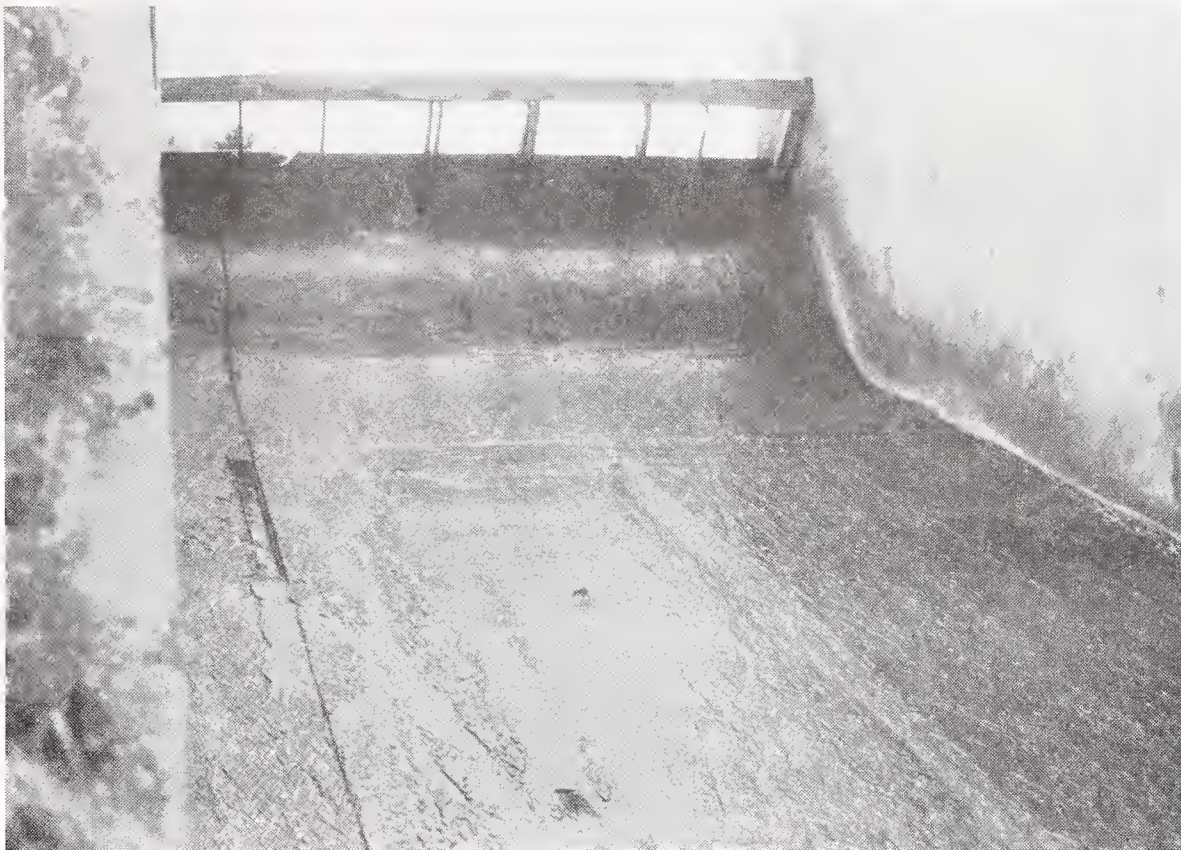
The spillway is in poor condition. The catwalk across the spillway crest is in need of repair. The wooden flashboard supports could accumulate debris and block the spillway. The concrete chute has become very rough due to erosion and severely cracked in places as a result of settlement and/or uplift. Near the top of the chute, cracking and spalling along the

construction joints has exposed the metal water stops permitting water to seep underneath the spillway floor. Water is escaping under pressure from underneath the floor slab at the bottom of chute causing a displacement of approximately three inches in the floor slab. This water pressure is likely to cause failure of the floor slab if not corrected. Failure of the floor slab could endanger the dam embankment. Settlement, uplift, and cracking has also occurred in the stilling basin walls and baffle blocks. Erosion is taking place at the stilling basin wing walls, most severely on the right (south) side, and silt and riprap have deposited in the stilling basin floor. The spillway is probably not capable of passing its estimated maximum discharge of 1030 cfs without failure of the floor slab.

Photo No. 3 - Top of Spillway  
The spillway floor is cracked exposing  
metal water stops.

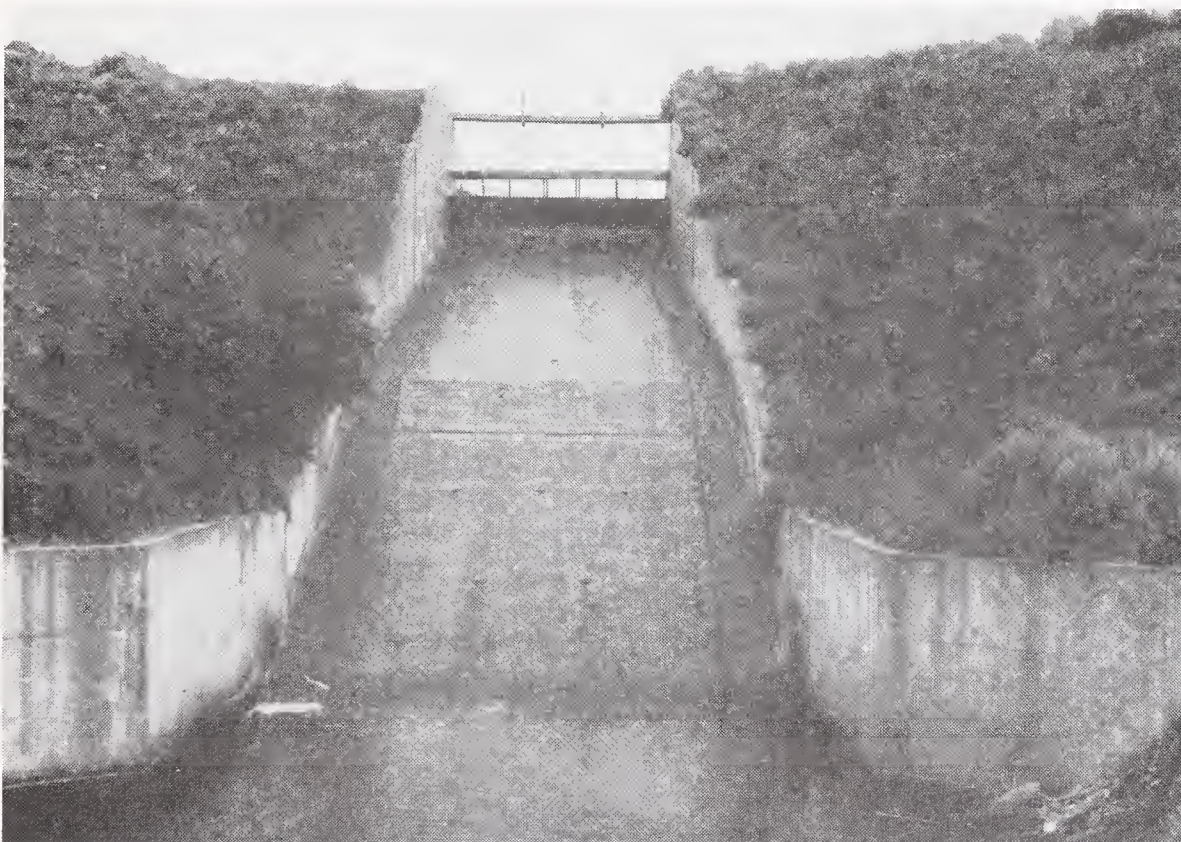
Bank erosion was observed in the spillway stilling basin area (Photos 4 and 10 of Appendix B). The erosion is undercutting and exposing the end of the wing walls. This erosion does not seem to be affecting dam stability currently but could eventually affect the structural stability of the spillway chute if not corrected.

Photo No. 4 - Spillway  
Water under pressure is escaping from  
beneath the bottom of the spillway  
floor slab.

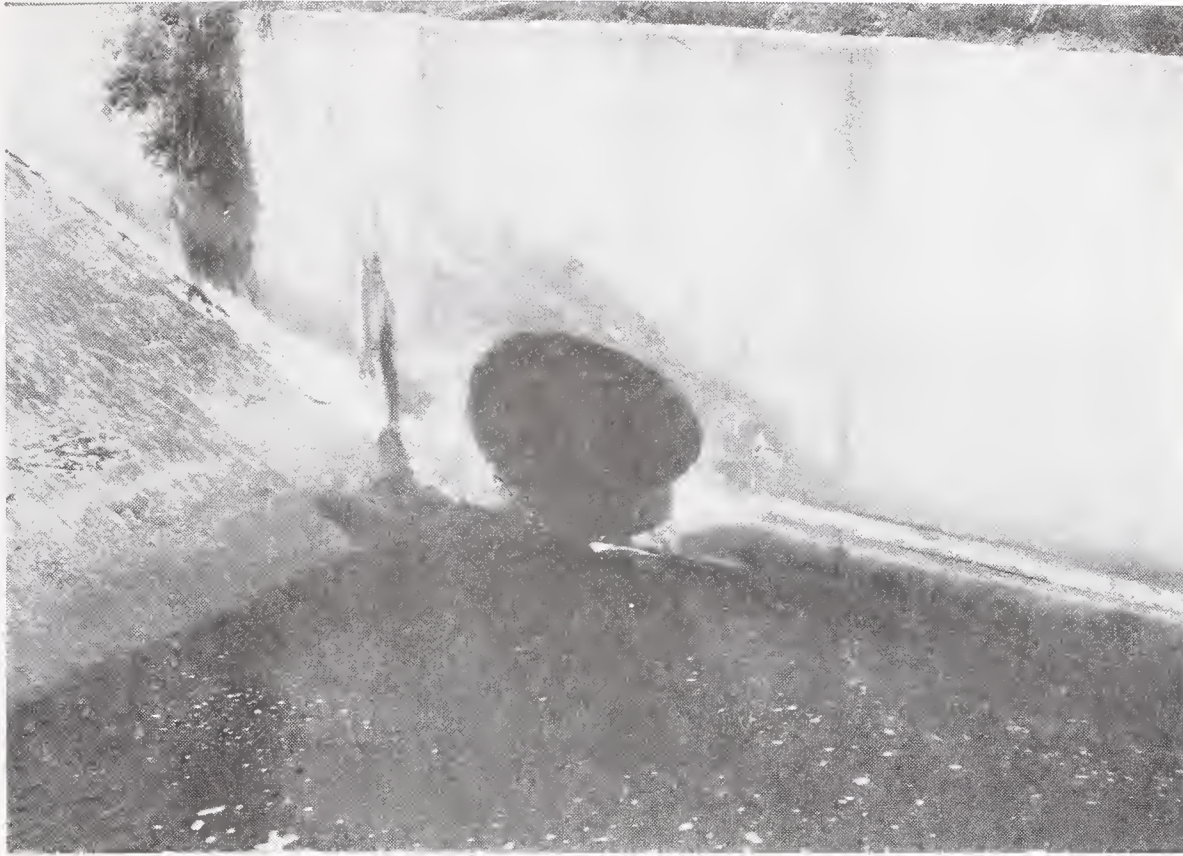
Photo No. 5 - Outlet Pipe

The outlet pipe and spillway share the same stilling basin. See Section 2.1.1 for inspection comments. It was also noted that there is a gap in the concrete around the outlet pipe where the pipe daylights at the stilling basin (Photo 5 of Appendix B).

A large crack in the stilling basin wall exists just upstream of the outlet pipe exit. There is a gap between the outlet pipe and the concrete in the stilling basin wall.

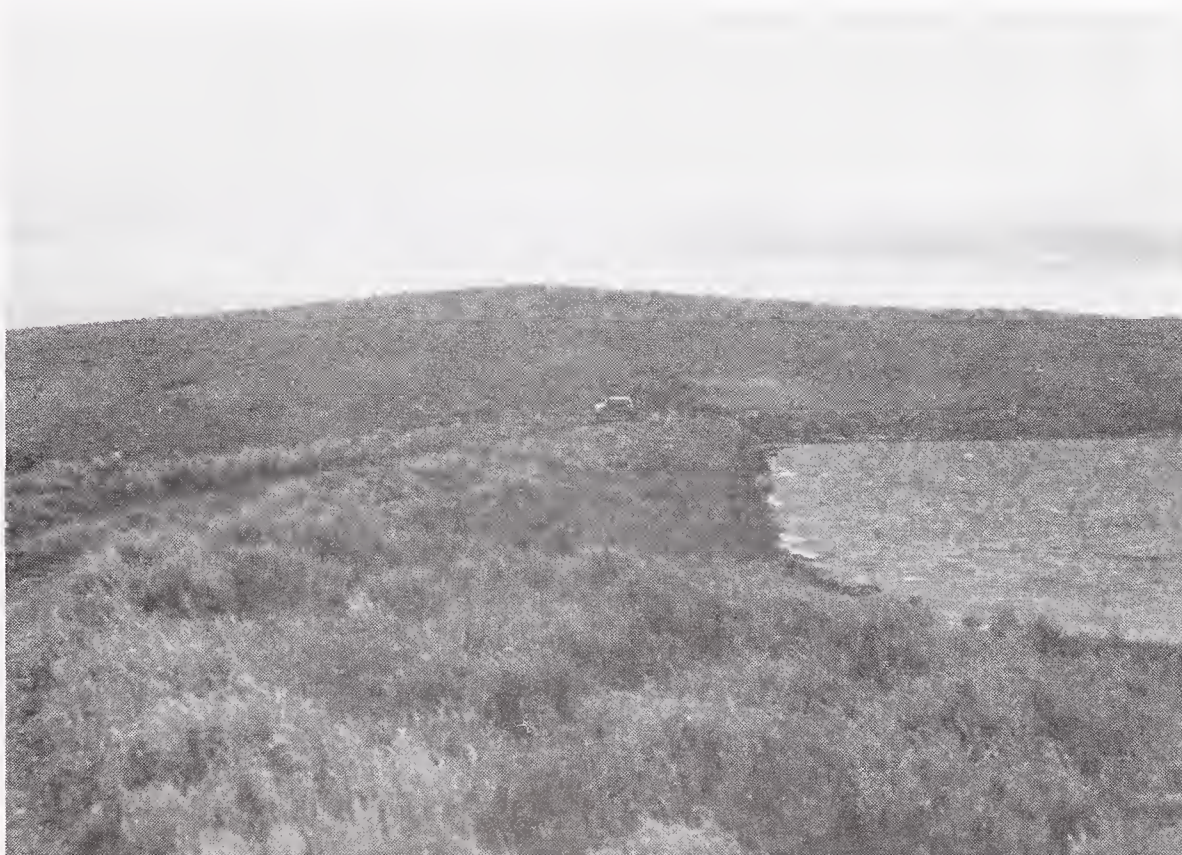
Photo No. 6 - Dam Crest

Accumulations of precipitation on the dam crest in the traffic path, combined with the vehicular traffic, has caused some ponding and created small erosion gullies (Photo 6 of Appendix B). A rather large depression has developed where the road (traffic) ascends the downstream slope of the dike.

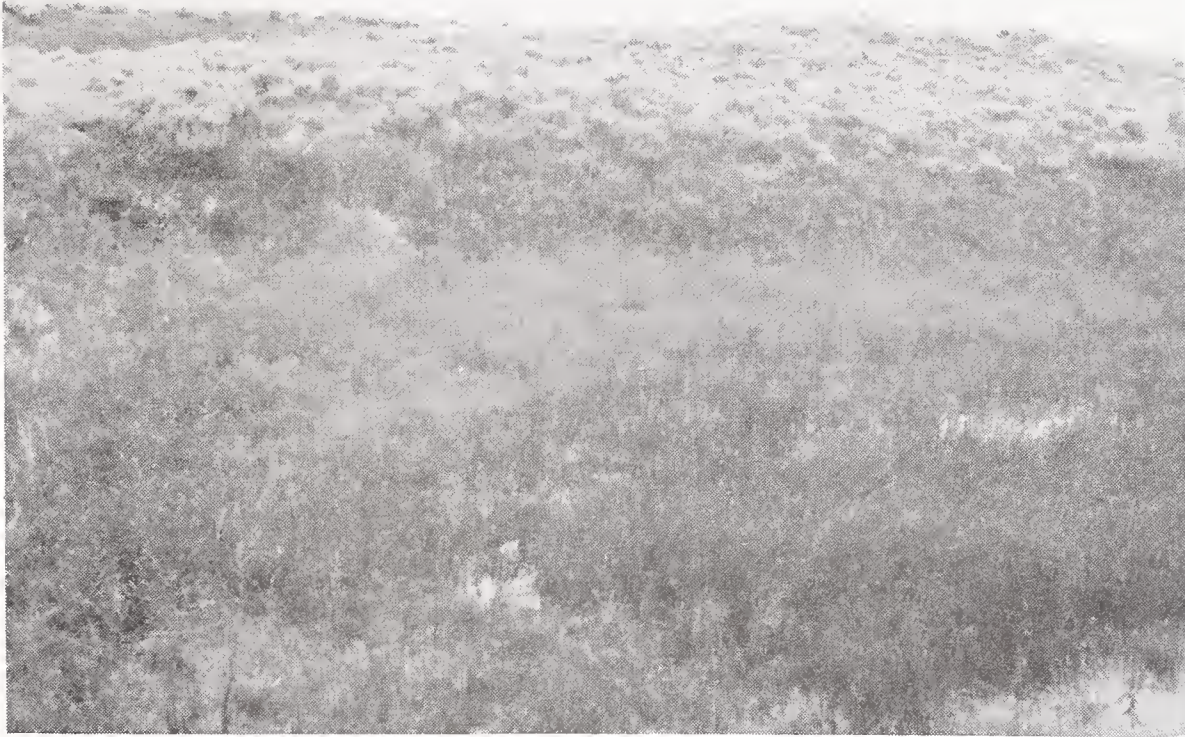
Photo No. 9 - Seepage Downstream of Dam  
Shown is the seepage through the left abutment approximately 250 feet downstream of the dam toe.

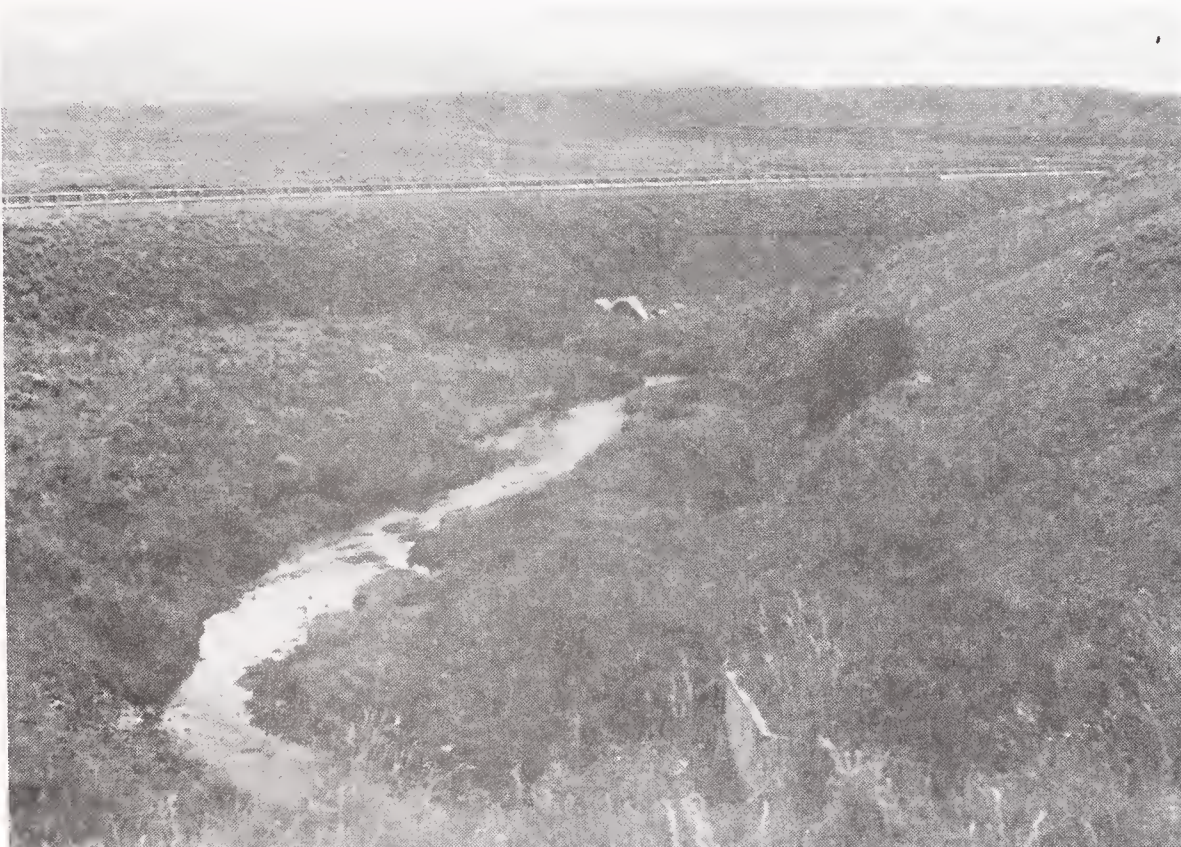
Photo No. 10 - Spillway and Outlet Works Return Channel  
Erosion is taking place at the stilling basin wingwalls. The highway embankment is 400 feet downstream of the dam embankment.
